Installation Instruction rear upper Brace bar for MK3

Item No. NC0-0966

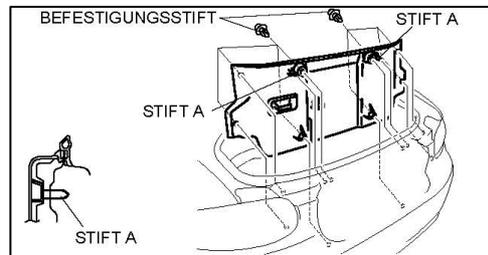
Remove the fasteners as shown below then disconnect the compartment light connector and then the trunk lid cancel switch connector. You will then be able to remove the trim.

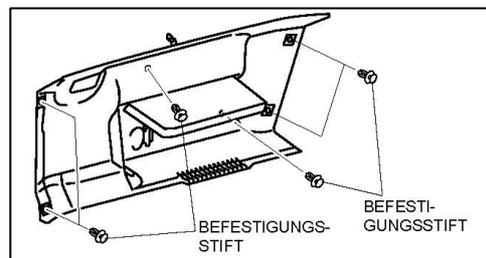
Remove the fasteners in the partition board, and then remove the trim.

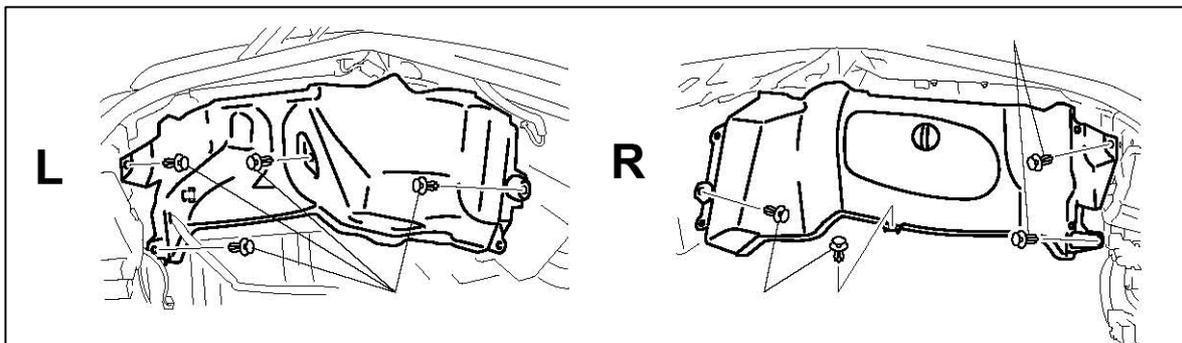
For the side trims. Remove all the fasteners as show below, and remove the two trims.
For the metal trim remove all screws.

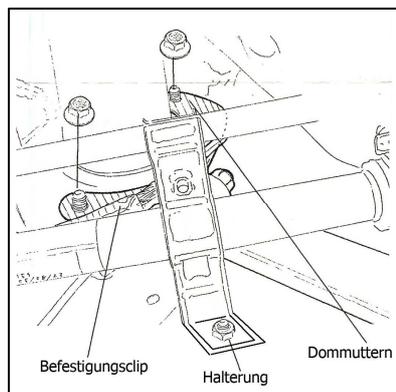
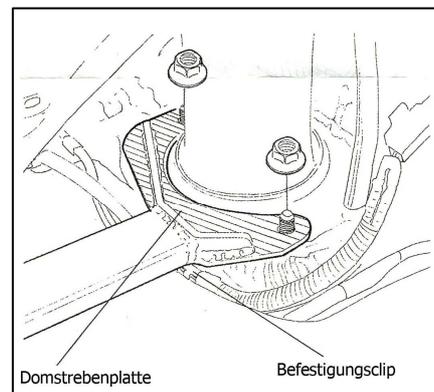
Undo the top mount retaining nuts as show below, and also the cable retainer nut.

Place the brace bar loosley on to the top mount studs ans ensure it is all sitting level. Then refit the nuts and tighten down the bar.

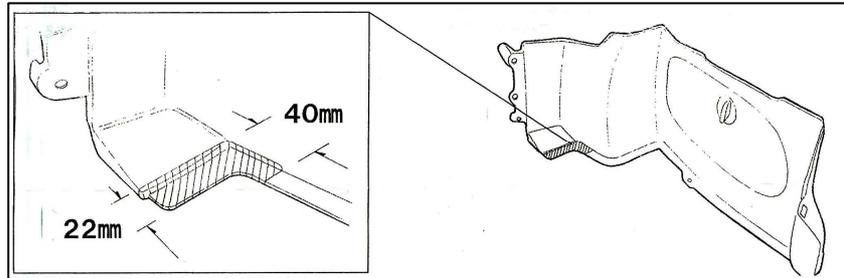
Right hand side cut out as shown.

When refitting the trims, they will need to be altered as follows. In the following sequence, trim the panels as shown below.

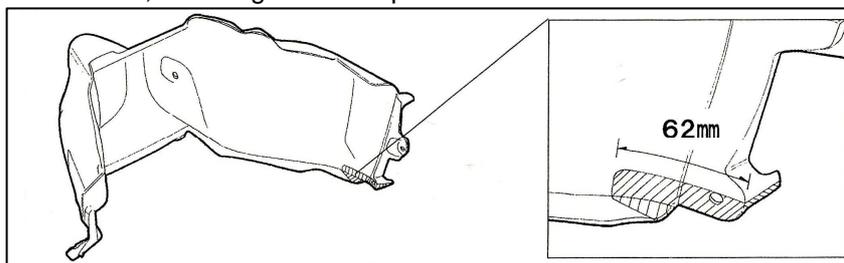
Left hand side cut out as shown, including the metal part.

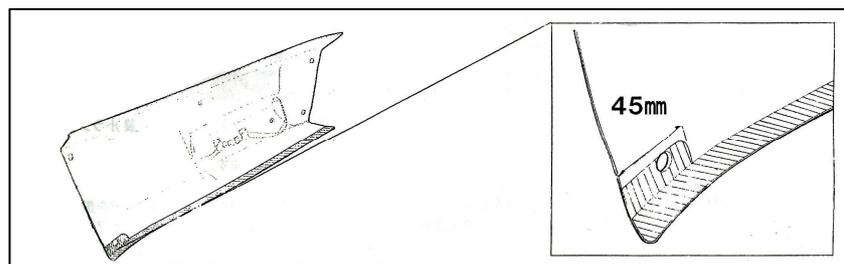
Rear panel cover cut out as show.

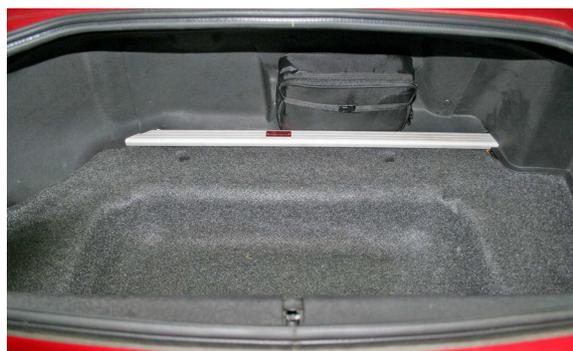
Once all the trims have been altered, refitting them ist he exact reverse of removal.
